Failure Risk Due to Creep Cracking of a High-Pressure Turbine Rotor

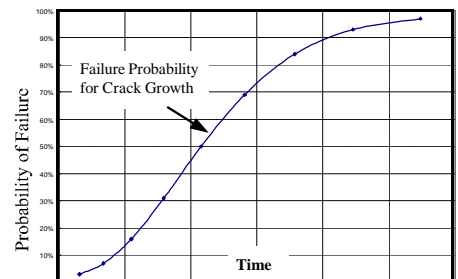
We applied this model for evaluation of a specific problem, and developed the 1st stage's failure probability as a function of time (Fig. 4).

Figure 4. Probability of failure for 1st stage blade-fit area of a HP turbine
