Penstock Reliability & Remaining Life Evaluation of a Hydro Electric Power Plant

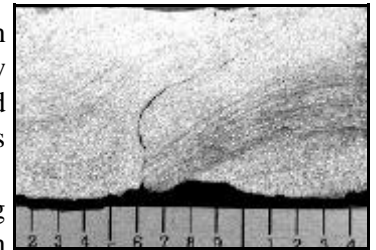
The penstock was comprised of two miles of various diameter and thickness piping. About half of the penstock was riveted and the remainder "lapwelded" (longitudinally seam forged welded) construction (*Fig. 2*). During the over-pressurization event, cracking and leakage occurred at a number of locations including a cast iron manhole and a cast iron venturi, which led to the shut down of the unit and raised concerns about the safety and long-term reliability of the penstock.

Figure 2: Cross section of a lap-weld showing a large existing flaw
